PROCEEDINGS OF THE FIRST SOUTHERN AFRICAN GEOTECHNICAL CONFERENCE,
5-6 MAY 2016, SUN CITY, SOUTH AFRICA

Long-term experience with a geogrid-reinforced landslide stabilization

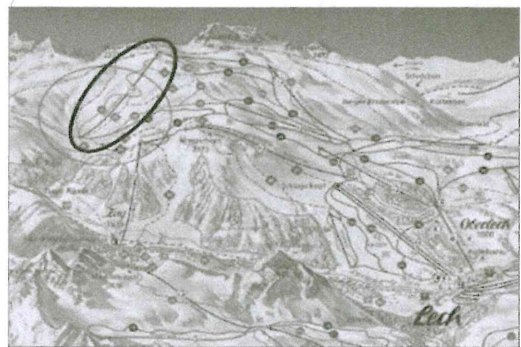
Figure 1. The ski region of Lech in the Austrian Alps (the Steinmähder Wand is marked).

In summer 1994 a landslide occurred in a natural slope just below the lower ski-lift station at the so called Steinmähder Wand (Figure 1).

In Lech snow fall usually starts in October and ends in April. The landslide occurred (surprisingly) in July 1994. There were some days at that time with up to 30 mm rain per day, but such values are believed not to be critical. Average precipitation over the year is in the range of 30 to 40 mm/day without a significant scattering. The most probable trigger was may be a “global” over-wetting due to massive “delayed” snow melting on the slopes above the lift station (Figure 1).

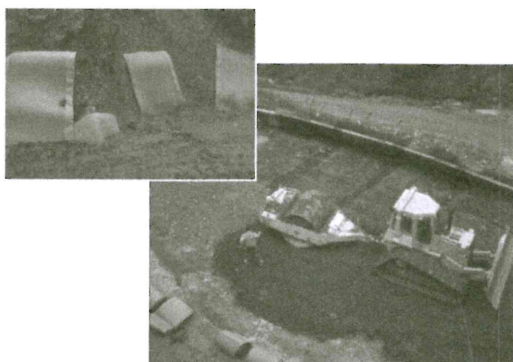
Figure 4. Construction: first layers, fill compaction by heavy equipment, formwork, geogrids, drainage mats.

Figure 4 shows at a glance all components of the system and the compaction procedure. Note the use of heavy compaction for the 0.75 m thick fill layers and the installation of drainage mats with a space in between (Chapter 6). One can see (Figure 5) that due to the lack of experience (the contractor had never built such a system) and the extreme time pressure the geometry at the front of the first geogrid-soil layers was not really precise. However, because this was not critical for stability and due to the anyway intended nature-alike final shape, this was tolerated.

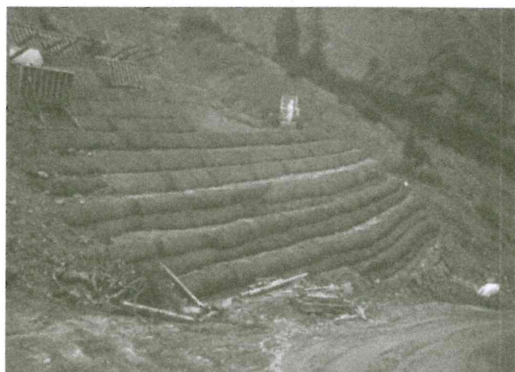
Figure 5. Construction: partial view of the geogrid-reinforced slope. Note the "bellies" at front of the first layers.

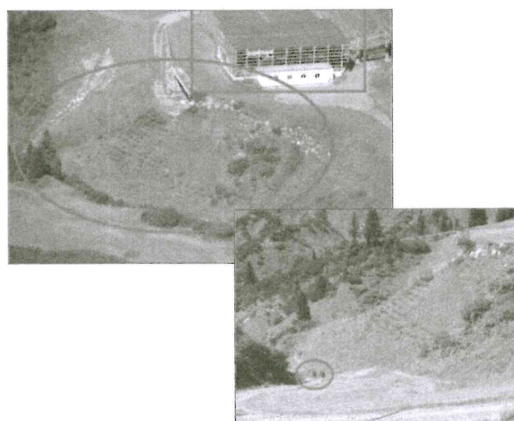
Figure 8. August 2014: left up: overview, reinforced slope is marked; right down: persons as a scale for the structure.

In Figures 8, 9 and 10 the present situation is depicted.

By the way: it is interesting to compare Figures 6 and 7 from 1994 with Figure 8 from 2014.

During the site inspection no indications of any relevant deformation of the geogrid-reinforced landslide stabilization system from 1994 were

found: neither vertical, nor horizontal. Although no precise measurements had been done over the twenty years passed, the systematic inspections of the owner over this period had attested no problems from the point of view of stability or serviceability of the reinforced slope or of the platform and station foundation on top.

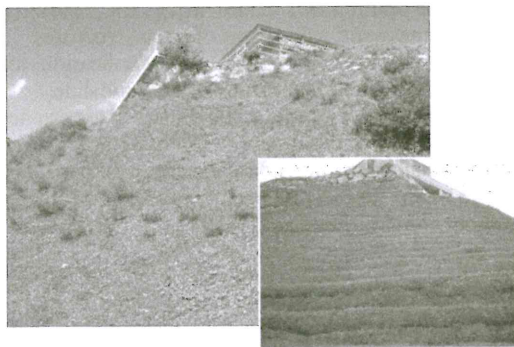
Figure 9. August 2014: view upslope.
