Evaluation of an airport pavement after almost 8 years of overlay rehabilitation with a polyester geogrid asphalt reinforcement

Keywords: polyester geogrid, asphalt reinforcement, overlay rehabilitation

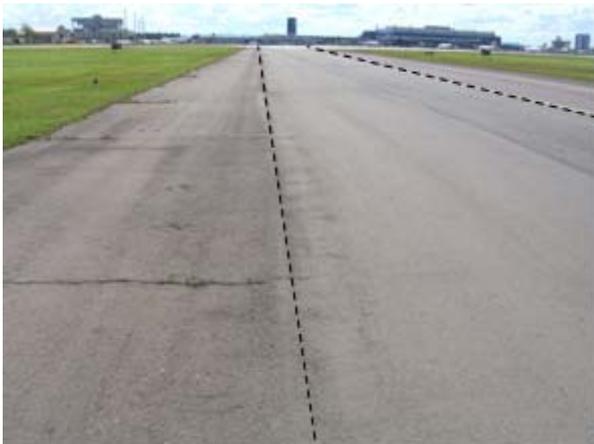
Figure 2. Overview of the studied section: view from the dockyards to the terminal.

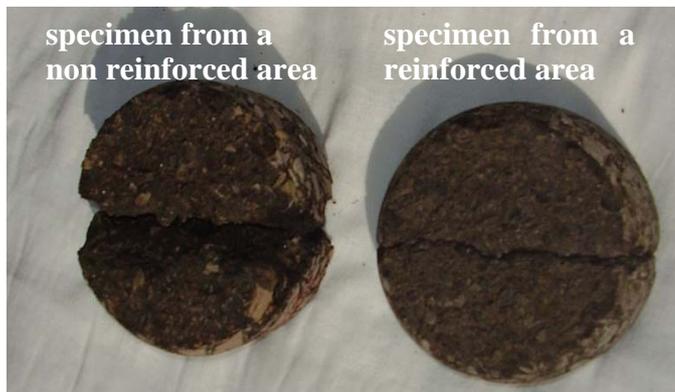
In the case of specimens taken from non reinforced zones, when including cracks, it was not possible to extract an integrate element since the crack took the full thickness and separated at least in two parts these pieces (Figure 9). In some of those cases, adherence between the two asphalt layers was lost during extraction, what was not the case of specimens taken from non cracked areas.

Figure 9. Specimens from areas with (right) and without (left) reinforcement.
