EXPERIMENTAL EVALUATION OF A POLYESTER GEOGRID AS AN ANTI-REFLECTIVE CRACKING INTERLAYER ON OVERLAYS

ABSTRACT: Dynamic fatigue test results are presented as part of a laboratory study for evaluation of the effect of a geogrid as an interlayer reinforcement between a cracked asphalt concrete layer and a non cracked one. Tests were performed with and without the grid, in order to ascertain its effects on crack control for both bending and shearing modes of loading. Prismatic beams supported by an elastic base were tested in a MTS equipment, at a loading frequency of 20 Hz. Significant increases in the design life due to reflective cracking and a different pattern of cracking were observed with the inclusion of the polyester geogrid used in the research, which indicates a remarkable reinforcing effect and a clear redistribution of stresses and dissipated energy.

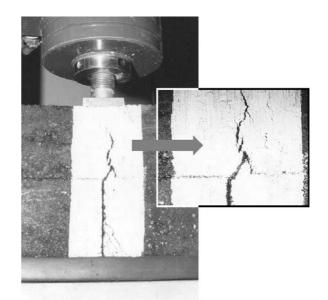
- In the beams without geogrid, a dominating reflective crack appeared in the overlay and grew vertically upwards (Figure 4). The cracking in the overlay started earlier and its propagation rate was faster. The tests stopped when the crack reached the overlay surface, breaking the specimen in two pieces.

Figure 4 - Crack propagation without geogrid

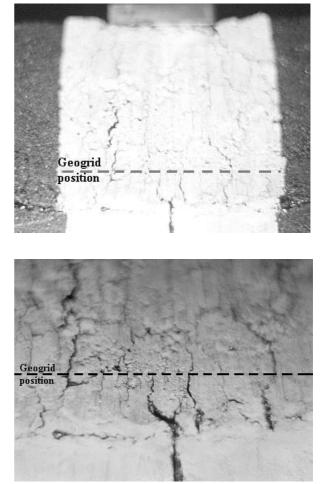
- In the beams with geogrid, the upward movement was intercepted when the crack reached the geogrid, leading to a new cracking pattern comprised by a series of micro-cracks (Figures 5, 6 and 7). No major reflection cracking was observed above the geogrid. The tests stopped when a plastic deformation of 2.5 mm under the loaded area was observed, since no crack reached the surface (except the shearing mode test at 549 kN/m² contact pressure Figure 7).

Figure 5 – Beam with geogrid in bending mode

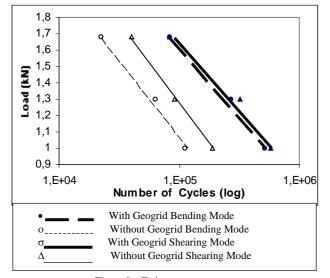
The fatigue curves for beams with and without geogrid at different loading levels, considering Shearing and Bending modes, can be seen in Figure 8. An effectiveness factor of geogrid (FEG), was calculated as shown on Tables 1, 2 and 3. This factor is given by: $FEG = N_{f(Geogrid)} / N_{f(Unreinforced)}$ with the fatigue life in each case being calculated as:

Figure 8 - Fatigue curves.

Figure 8 shows that the presence of the polyester geogrid had the effect of drastically reducing the influence of the load position on the fatigue life. This is in agreement with the hypothesis that the geogrid redistributed the stresses and strains in the overlay, possibly reducing the distortion energy density (associated with shear stresses) and making the performance of the overlay less dependent upon support conditions. It can be expected, therefore, that the anti-reflective cracking system here studied would be effective also in cases where the existing pavement is severely cracked, to the point where a major pavement reconstruction would be otherwise required.
